Manhole Inspection Summary

Manhole # S03WW1010MH

Insp Date: **8/16/06 12:00 AM**

Location Address: **3414 GLEN AVE**

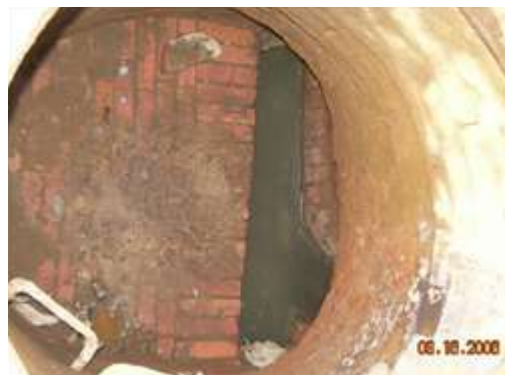
Top View

Adjustment, Corbel and Barrel infiltration.
Bench and Channel debris.

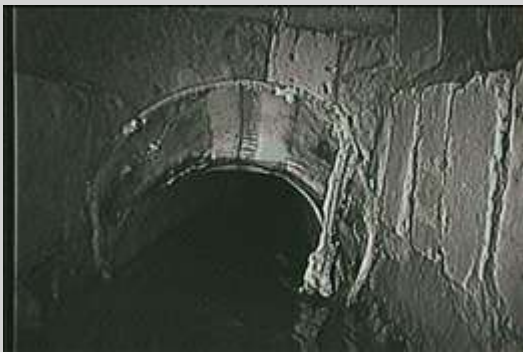
8 in. Circular Gravity Sewer Pipe Out @ 12 O'Clock

Pipe Material: **Clay** ☒ Pipe Lined

Infiltration: **None** Pipe Seal Cond: **Unknown**

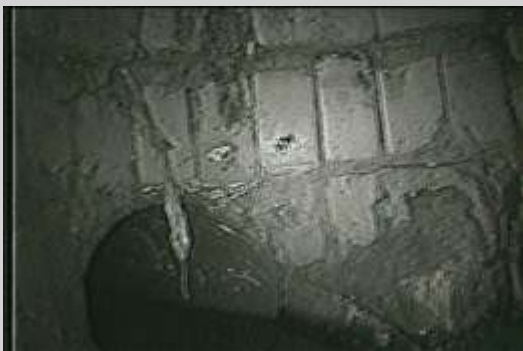
8 in. Circular Gravity Sewer Pipe In @ 5 O'Clock

Barrel root intrusion and infiltration.

Infiltration: **Evidence** Pipe Seal Cond: **Roots**

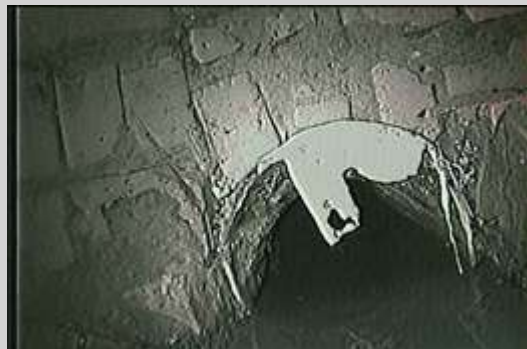
Pipe In @ 6 O'Clock

Infiltration: **Evidence**

Pipe Seal Cond: **Roots**
